## The Effect of Surface Treatments on the Bond Strength of a Nonprecious Alloy–Ceramic Interface: An Invitro Study

**Abstract** The purpose of this study was to compare the effect of seven different alloy surface treatments on the bond strength of the porcelain-metal interface. Three layers of opaque porcelain and a measured thickness of dentin porcelain were applied to nickel–chromium alloy. A tensile bond strength test was used. The alloy surface treatment that exhibited the highest bond strength was sandblast + surface grinding + sandblast + de-gas, whereas the alloy surface treatment that exhibited the lowest bond strength was sandblast + surface grinding + sandblast + steam cleaning + de-gas. There was a significant difference between the two methods ( $P < 0.05$ ). It was concluded that de-gassing the alloy prior to porcelain application increased the bond strength and excess surface grinding of the alloy reduced bond strength; steam cleaning the alloy surface prior to de-gassing and porcelain application also significantly reduced the bond strength.

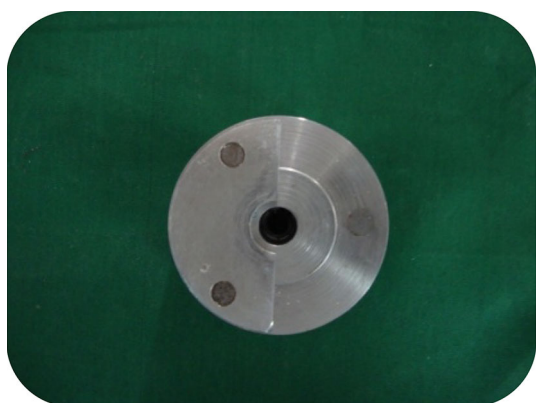
**Fig. 1** Two portions of the stainless steel mold fitted together

1. For the study a stainless steel mold was fabricated which consisted of two parts; lower base with a vertical cylindrical perforation (13 mm high, 8 mm in diameter) and upper removable portion of semicircular

form which had a central perforation (3 mm high, 10.4 mm in diameter) that fit perfectly in the upper face of lower (Fig. 1). Fabrication of wax cylinders fabrication, porcelain build-up and shear strength testing were accomplished using a stainless steel mold.

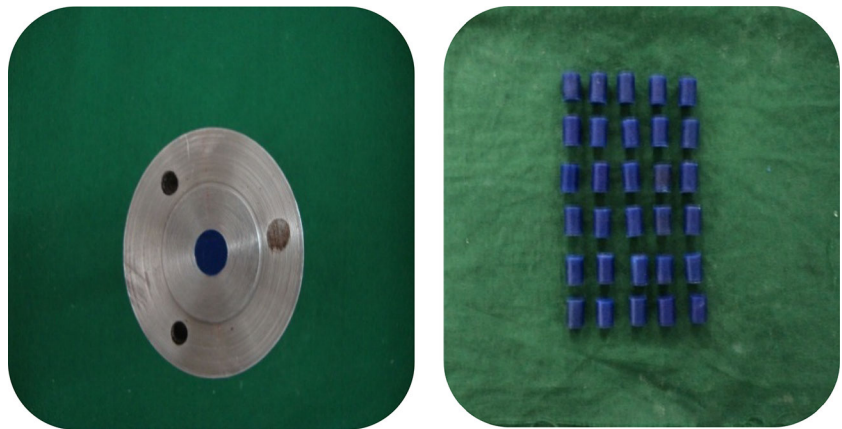
**Fig. 2** Wax patterns of test alloy samples

Thirty-five standard wax cylinders (13 mm high, 8 mm diameter) were prepared using inlay wax (Bego, Germany) and stainless steel mold (Fig. 2). These wax cylinders were then sprued and de-bubblezing agent (Aurofilm-Bego, Germany) was applied. Investing was done using phosphate-bonded investment (Bego, Germany) (Fig. 3). After 30 min of bench setting the rings were placed into room temperature burnout furnace (Unident, India) and heated gradually to 900 °C. The casting ring was kept for 30 min to allow complete wax elimination. Casting was accomplished using Ni–Cr alloy (Ni-65.2 %, Cr-22.5 %, Mo-9.5 %, Nb–Si–Fe–Mn) (Bego, Germany) in an induction casting machine (Bego, Germany).

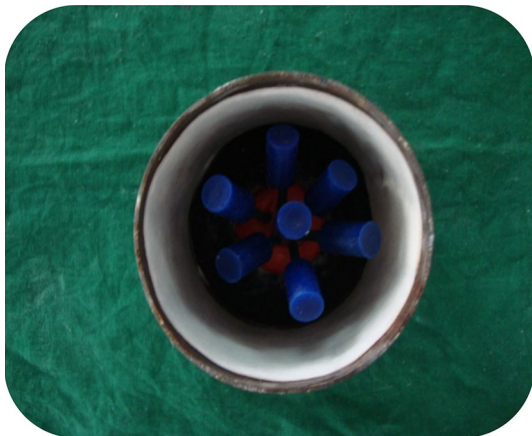
**Fig. 3** Sprued wax patterns assembled in the casting ring

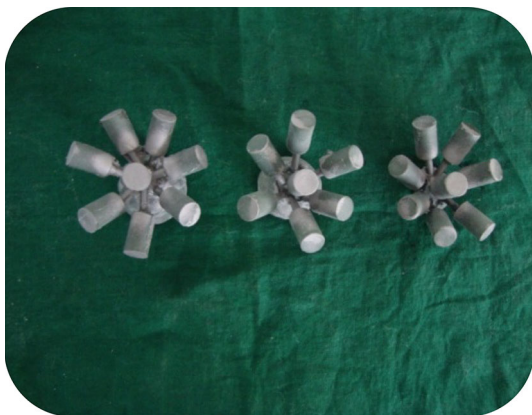
**Fig. 4** Test alloy samples after casting

After casting, each ring was bench-cooled and the casted alloy samples were divested (Fig. 4); any residual investment and the oxide layer on the surface of the castings was removed using 50- $\mu$ m aluminum oxide abrasive at six bars of pressure in sandblasting unit (Bego, Germany). The sprues were removed using carborundum disks in alloy grinder (Ray foster) and the area where the sprues were attached was ground smooth using high speed micromotor handpiece (Marathon).

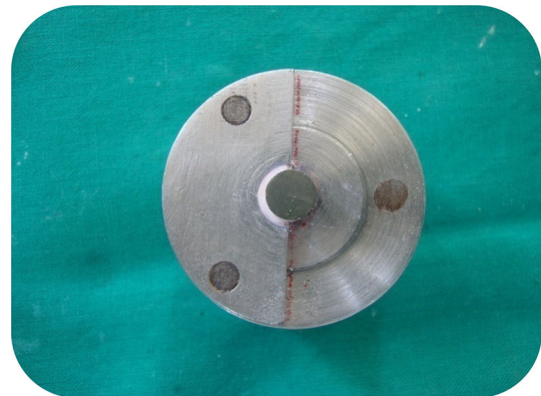
**Fig. 5** Body porcelain application

body porcelain (Ceramco3, Dentsply, USA). The cylindrical specimens were positioned in the lower half of the mold, with approximately half of its height above that. As the upper part of the mold, with circular form, presents a hole with an 10.4 mm diameter and 3.0 mm height, it provided a porcelain layer with similar dimensions for all specimens, that is,  $1.2 \times 3.00$  mm, with an area of  $0.2827 \text{ cm}^2$  (Fig. 5).

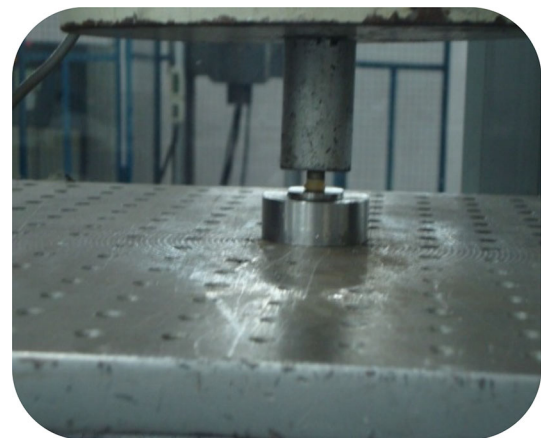
**Fig. 6** Shear bond testing

After the applied porcelain area was measured, the lower part of the mold was taken along the test sample to an universal testing machine (Fig. 6). The test configuration was then loaded in shear strength, with generation of forces perpendicular to the ceramic metal interface at a crosshead speed of 1 mm/min until failure occurred and failure loads were recorded in Newtons. Compressive force

was applied to the upper portion of the specimens and stress was produced in the opaque/metal interface.

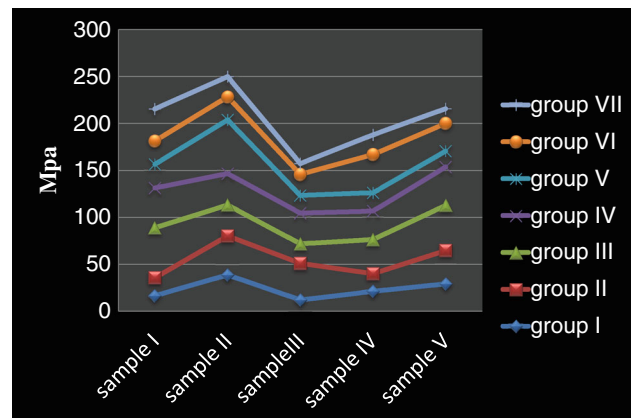
**Graph 1** Mean Shear bond strength values of group I to group VII test samples

The results (Graph 1) indicated that the alloy surface treatment that exhibited the highest bond strength was sandblast + surface grinding + sandblast + de-gas (group III) was followed by sandblast + surface grinding + sandblast + de-gas + sandblast (group IV) whereas the alloy surface treatment that exhibited the lowest bond strength was sandblast + surface grinding + sandblast + steam cleaning + de-gas (group VII). There was a significant difference between the two methods group III and group VII ( $P = 0.035$ ).

The results indicated that a nonprecious alloy that is prepared with the following surface treatment combinations has an important function in producing a good bond between the alloy surface and ceramic: sandblast + surface grinding + sandblast de-gas (Group III-37.9 Mpa), or sandblast + surface grinding + sandblast + de-gas + sandblast (Group IV-36.0 Mpa).
