Case Report

Restoration of esthetics and function in a patient with amelogenesis imperfecta: A clinical report

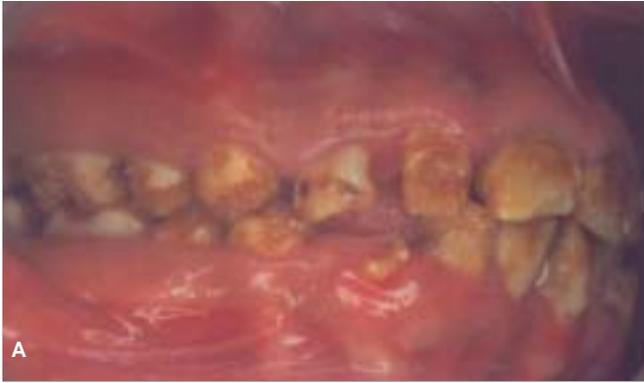
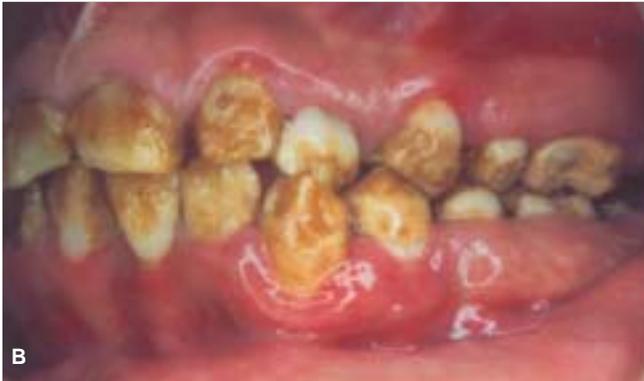
A 16 yr old individual reported to our department with a chief complaint of unesthetic smile due to discolored teeth [Figure 1]. No family history of this condition was reported. Panoramic radiographs revealed that the patient had retained maxillary deciduous canines on the right and left sides. The maxillary right and left canines were impacted. Mandibular third molars on both right and left sides were retained [Figure 2].

Figure 1: A and B, Pretreatment right and left buccal view of teeth in maximal intercuspation

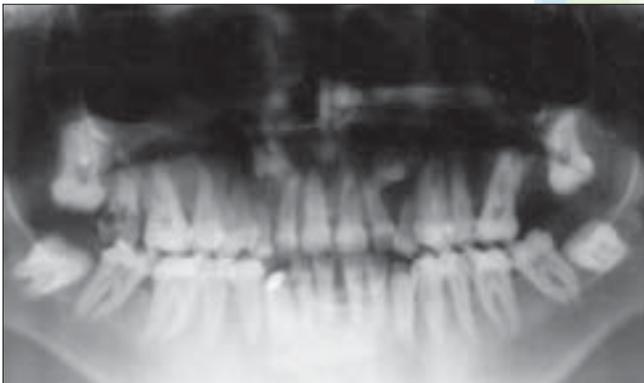
Figure 2: Panoramic radiograph. Radiodensities of enamel and dentin were similar

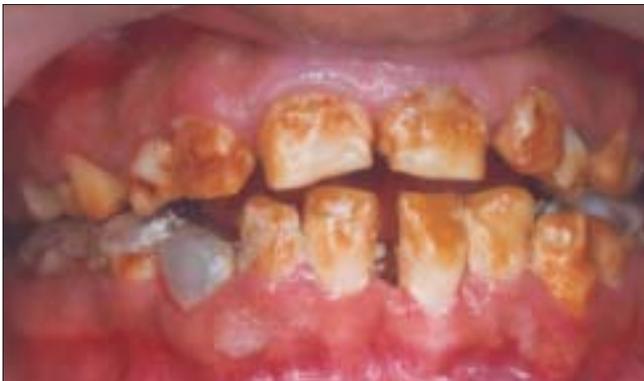
Figure 3: Frontal view of occlusal splint in place

Complete arch maxillary and mandibular impressions were made with irreversible hydrocolloid (Alginoplast; Heraeus Kulzer, South Bend, Ind), and used to obtain diagnostic casts, using Type III dental stone (Labstone, Kalabhai Karson, Mumbai, Ind). Face-bow transfer was done and interocclusal records were made to mount the casts in centric relation on a semi-adjustable articulator (Hanau Series H2; Water Pik, Fort Collins, U.S.A). As the patient had less vertical dimension of occlusion, the vertical dimension had to be increased by 3 mm using an occlusal splint [Figure 3]. The patient was treated with occlusal splint for a period of 4 weeks and report back. Phonetics was used to assess that the increase of vertical height was within the physiologic limits.

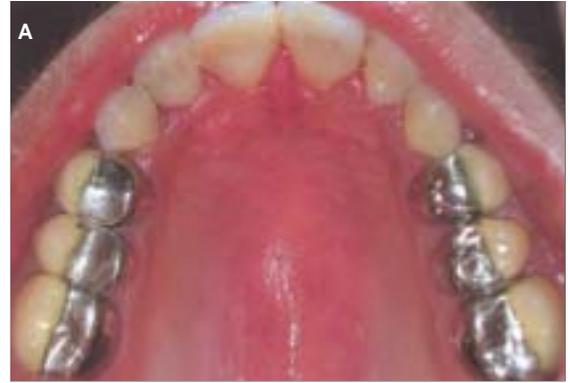
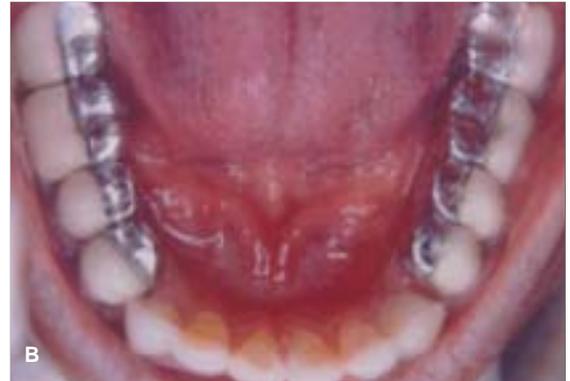
Figure 4: Post-treatment occlusal views. A, Maxillary; B, Mandibular.

The maxillary premolars and first molars along with the mandibular premolars, first and second molars on both right and left sides, were prepared and rehabilitated simultaneously to receive metal-ceramic crowns. The teeth were prepared to allow for 1.5 mm of restorative material on the occlusal surfaces. The porcelain on the facial surface extended over the cusp tip and half of the way down the lingual incline of the facial cusp on maxillary premolars and molars. A shoulder of 1.5 mm on the facial side and a chamfer of 0.5 mm width was prepared on the lingual side. Tooth reduction was kept to a minimum. All tooth preparations were completed without sharp line angles.

A trial evaluation of the metal substructure, prior to build up of the ceramic material, enabled final occlusal refinement. The crowns were cemented with glass ionomer cement (GC Fuji I, GC Corporation, Tokyo,

Japan) using the manufacturer's recommended powder/liquid ratio. The vertical dimension of occlusion was carefully maintained during the period of provisionalization and through the completion of restoration [Figure 4].

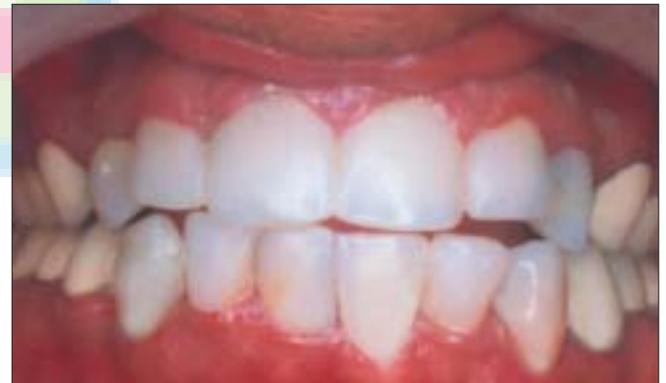
Figure 5: Composite restorations on the maxillary and mandibular anterior teeth

The maxillary and mandibular anterior teeth were then prepared to receive composite restorations (CHARISMA, Heraeus Kulzer, Germany). Shade matching was done according to the skin tone, because all the teeth were being restored. [Figure 5].
