The Journal of Indian Prosthodontic Society

Case Report

The removable occlusal overlay splint in the management of tooth wear

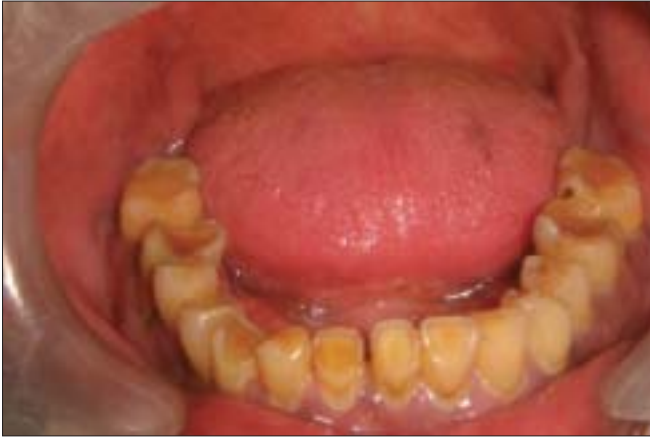
Figure 1: Preoperative view showing excessive occlusal wear and an uneven occlusal plane of the mandibular teeth

No significant systemic findings were elucidated. Clinical examination revealed an edentulous maxillary ridge and a full complement of mandibular teeth. The mandibular teeth showed excessive occlusal wear, questionable pulpal involvement and cervical erosions and/or abrasion. Further, the mandibular posterior teeth demonstrated an uneven occlusal plane [Figure 1].

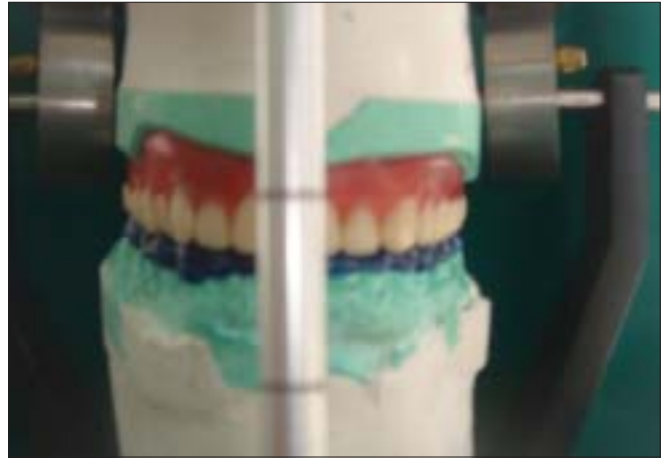
Figure 4: Final wax-up in occlusion with maxillary teeth

8. The mandibular posterior teeth were then waxed-up in occlusion with the maxillary posterior teeth [Figure 3]. This arrangement ensured a uniform and harmonious occlusal plane. Balancing contacts were achieved bilaterally [Figure 4].

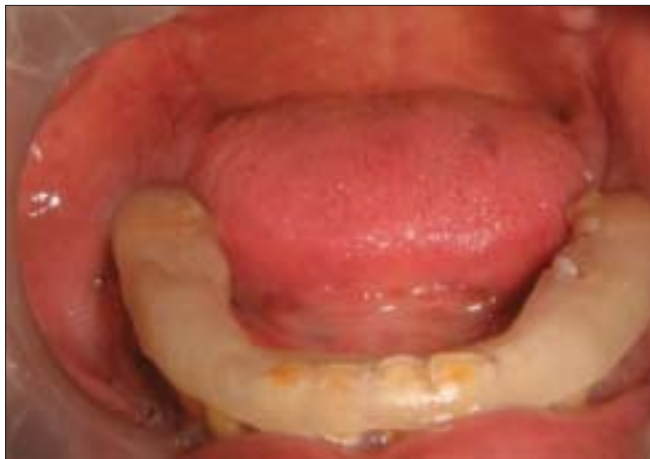
Figure 2: Preparation guide placed in the mouth

A preparation guide was created that allowed the planned amount of odontoplasty to be transferred accurately and conveniently from the cast to the mouth.^[5] A uniform, clear, self-cure acrylic template was fabricated over the occlusal surface of the mandibular teeth on the cast. The cusps to be modified were marked on the cast with a contrasting colored pencil.

This clear acrylic template was then placed over the unmodified cast. The colored contrasting marks can be observed through the template. An acrylic trimming bur was then used to simultaneously trim both the template as well as the sharp cusps up

to the desired level of modification. This created openings on the occlusal and incisal surfaces of the template to indicate the position of the tooth structure before they were modified. The margins of the openings indicated the extent of tooth reduction, i.e, when the template was seated in the mouth, the natural teeth would protrude through these openings [Figure 2].

This template was then placed in the mouth and the mandibular teeth were reduced till the margins of the openings on the template.

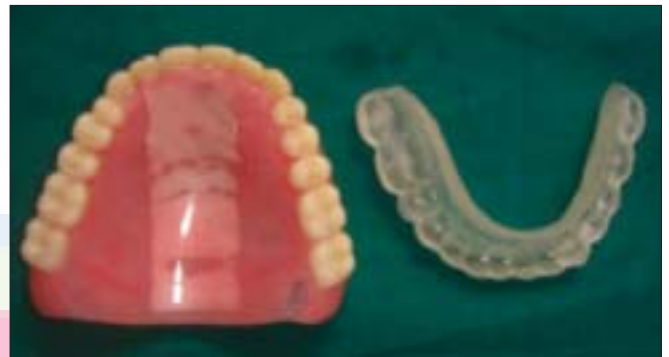
Figure 5: Finished dentures

14. The dentures were then finished, polished [Figure 5] and inserted in the mouth with minor occlusal adjustments with the help of a clinical remount [Figure 6].

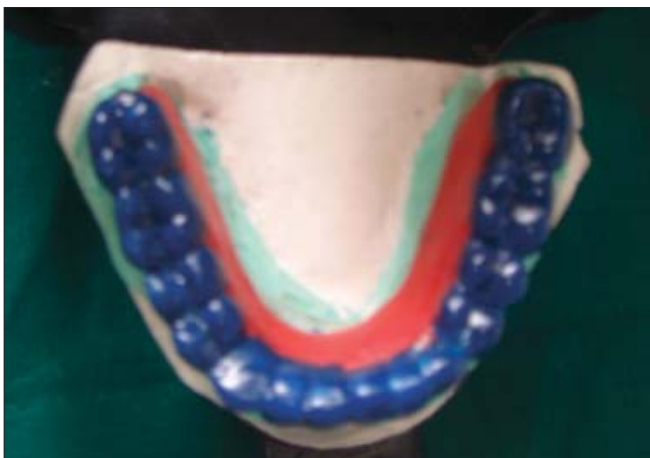
Figure 3: Mandibular teeth wax-up

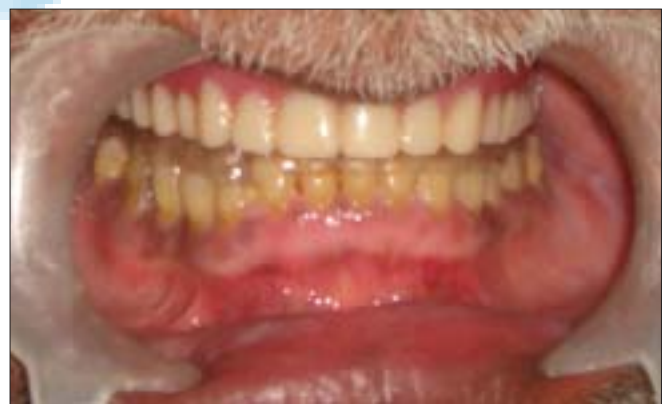
Figure 6: Postoperative view with the splint in place
