Original Article

The marginal and internal discrepancy of zirconia coping milled by two computer-aided design-computer-aided manufacturing systems

Abstract
 Aims: This study aimed to evaluate the marginal and internal discrepancy of the zirconia coping fabricated by two dental computer-aided design–computer-aided manufacturing (CAD-CAM) systems.

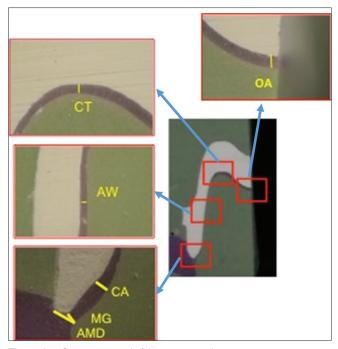
Figure 2: 2 Cross-sectional of the six-points discrepancy measurement. OA = Occlusal Adaptation, CT = Cusp tip, AW = Axial wall. CA = Chamfer area, MG = Marginal Gap, AMD = Absolute Marginal Discrepancy

The discrepancies of the crown are measured at six points on the definitions defined by Holmes *et al.*^[8] as following:

- 1. Occlusal adaptation (OA) is the internal adaptation of the surface of the crown to the abutment at that midpoint from the facial and proximal
- 2. Cusp tip (CT) is the internal adaptation of the surface of the crown to the abutment at the CT
- 3. Axial wall (AW) is the internal adaptation of the retainer walls at the midpoint of the AW (2 mm occlusal to the margin of the abutment)
- 4. Chamfer area (CA) is the internal adaptation of the substructure at the point of the biggest diameter of CA
- 5. MG is the perpendicular measurement from the internal surface of the substructure to the AW of the preparation at the margin

6. Absolute marginal discrepancy (AMD) is the distance from the margin of the substructure to the cavosurface angle of finish line preparation.

The schematic picture of the measuring point is shown in Figure 2. The AMD and MG were examined to represent the marginal discrepancy, while the CA, AW, CT, and OA were examined to represent the internal discrepancy.

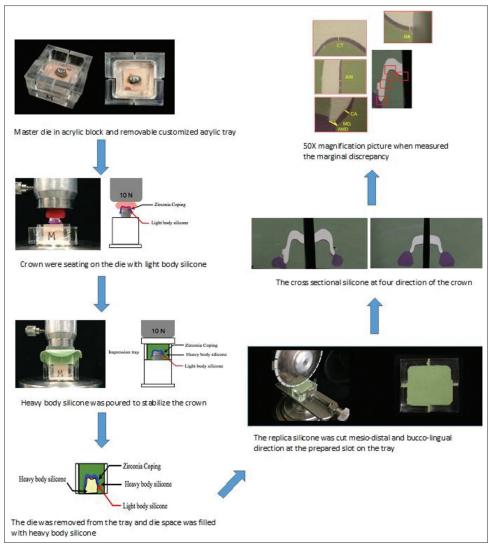
Figure 3: Schematic picture of the silicone replica procedure

The silicone replica technique was performed by filling light body silicone into the crown and placed onto the master abutment. Ten N load was applied on the occlusal surface for 10 s, then removed the load and waiting until silicone got complete set. The silicone films represented the discrepancy between the crown and abutment. The crown was stabilized by heavy body silicone in a customized plastic tray. After removal of the crown, the different color of heavy body silicone was filled into the crown to represent the abutment. A cutting machine was used to cut the silicone in buccolingual and mesiodistal direction along the slot of the tray to ensure the position

of the measurement. The schematic picture of the silicone replica technique procedure is shown in Figure 3. Data were analyzed using two-way ANOVA and Games–Howell *post hoc* test.
